Section 6 – Findings

6.2. Geomorphic Condition of the West Branch

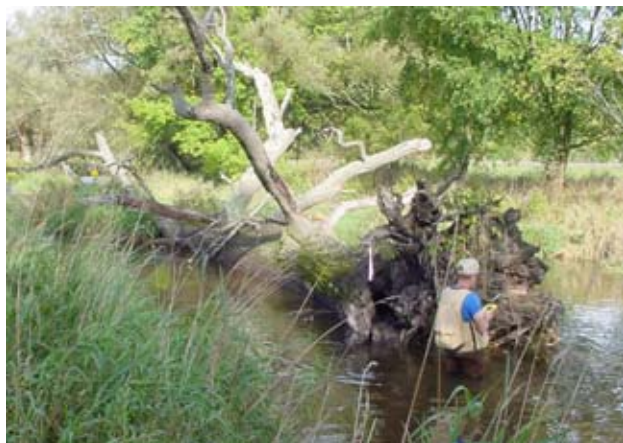
Figure 6.1 Using a hand held GPS receiver to locate a debris jam downstream of South Kortright.

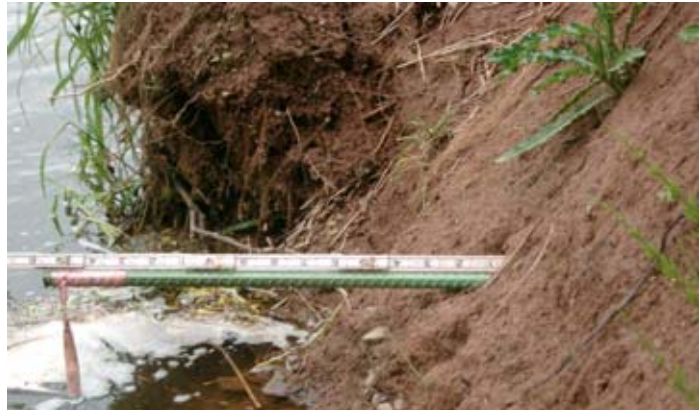
Figure 6.2 Measuring erosion loss using the bank-pin method at cross-section 53 just upstream of Delhi.

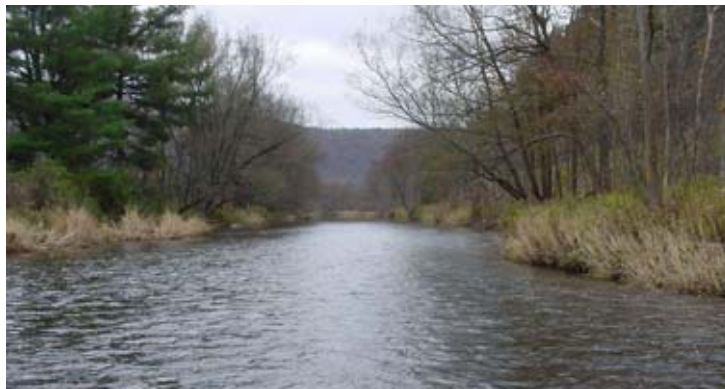
What is not apparent in **Table 6.1** is that the river has long reaches of planar bed, which came to be referred to as “long runs” by DCSWCD personnel (see **Figure 6.3**). The cause of these long runs is not known, but they have been observed by our personnel on other streams in the northeast where they appear to be quite common. They are devoid of features (riffles, pools), cross-sections tend to be nearly rectangular and the bed is usually flat and level. In this sense, they interrupt the pool-riffle sequence; they have been observed occupying a length that would normally be occupied in similar reaches by one or more pool-riffle sequences. They can be stable, especially if the riparian vegetative buffer is thick, with a good root mass to hold the banks in place (see **Figure 6.3**). Their significance is unclear. As a working hypothesis, since they do interrupt the normal pool-riffle sequence, it is assumed that they are most likely a response by the stream to a past disturbance, but it remains unclear whether long runs represent a current problem.

Figure 6.3 Example of a long run just below Bloomville at cross-section 43.

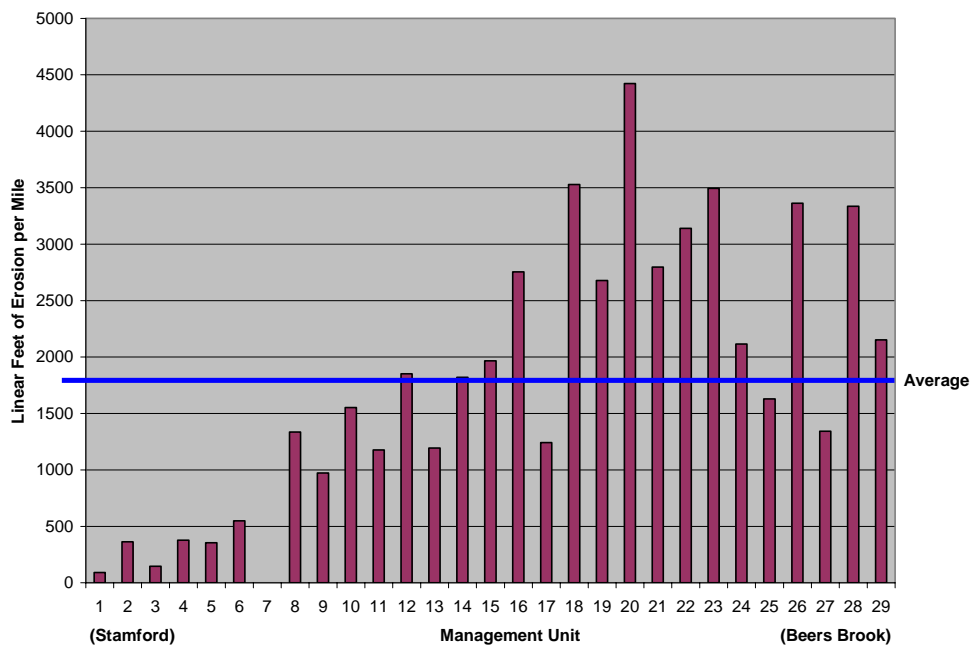
Chart 6.1 Linear Feet of Erosion per Mile by Management Unit

- The river being small and lacking erosive power, especially in reaches with low slope.
- The river is channelized and hardened within the Village of Stamford.
- A lack of West Branch and sub-basin development and agriculture in the upper portions of the watershed.
- Healthier riparian vegetative communities to hold stream banks in place.

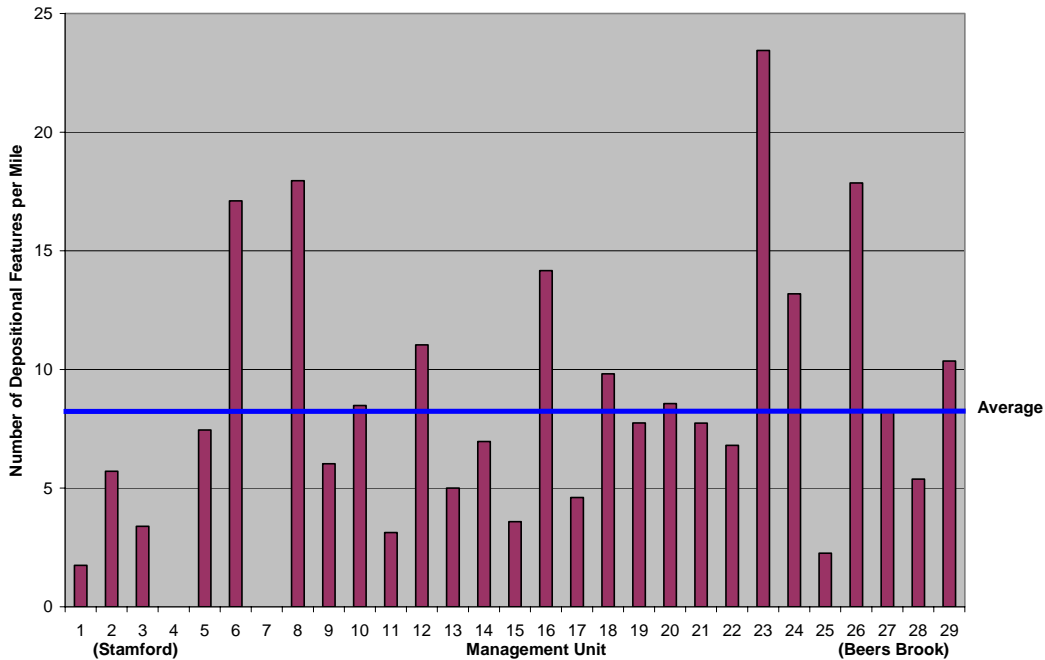
Chart 6.2 Depositional Features per Mile by Management Unit

Chart 6.2, below, graphically illustrates the rate of depositional features per mile per management unit. Note that the rate of depositional features tends to increase in the downstream direction. This is particularly true from management unit 23 to management unit 29. This is probably due to:

- Excessive sediment load being contributed by the tributaries along the length of the main stem.
- The total sediment entering the stream from the upstream eroded banks being more than the stream can move.
- Stream slope decreasing to the point that it can no longer transport the sediment being made available to it.
- Stream depth decreasing and/or stream width increasing to the point that it can no longer transport the sediment being made available to it.
- Some combination of the above factors.

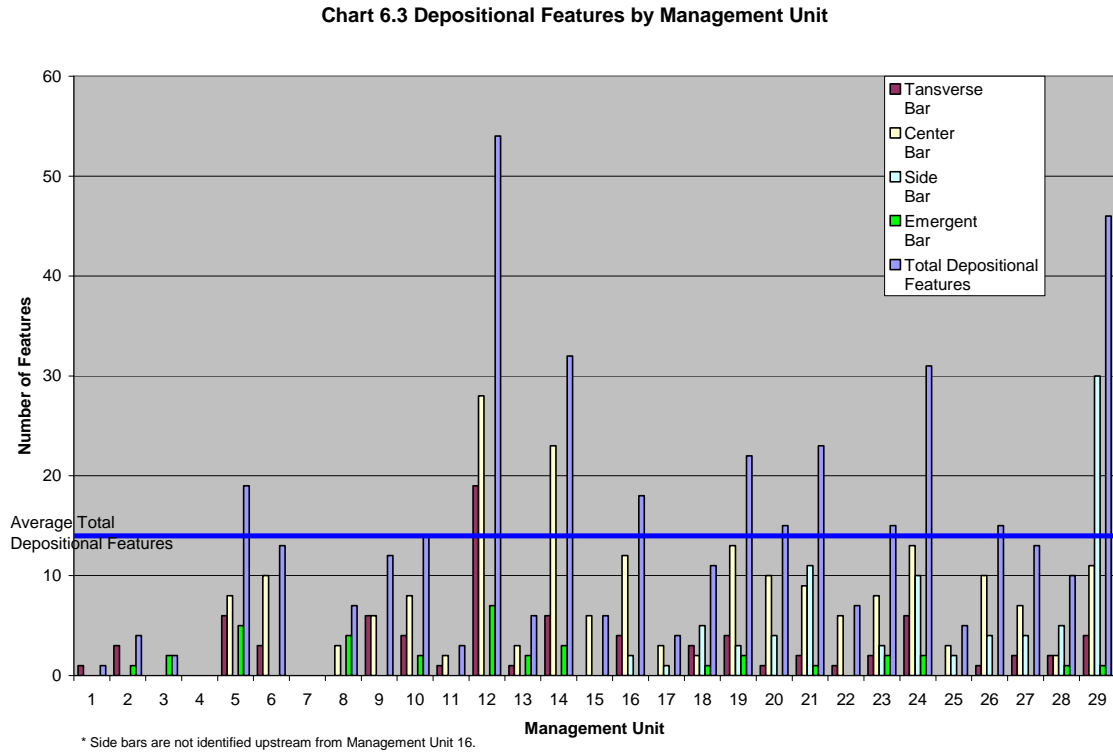
Chart 6.3, below, graphically illustrates the depositional features by type for each management unit. Note that center bars and side bars are the most common depositional features.

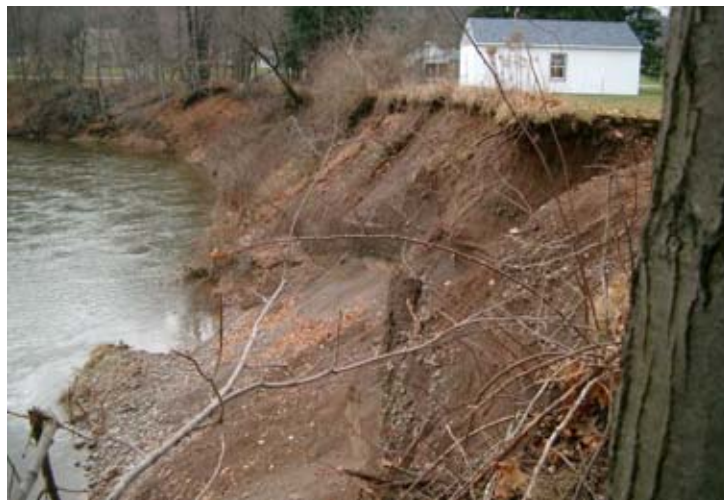
Figure 6.4 Severely eroding bank in the Village of Walton (December 2004).

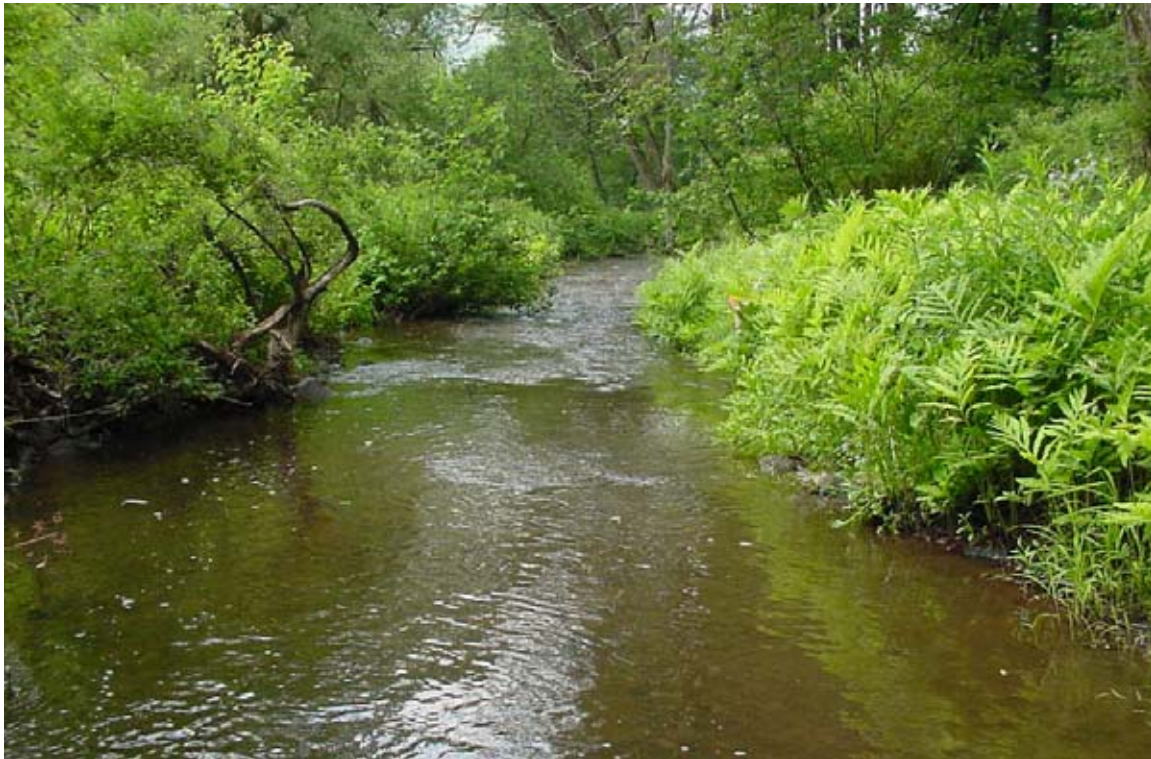
Figure 6.7 Natural riparian forest buffer near the Village of Stamford. Note abundance of vegetation and lack of erosion. Stream also has noticeable natural riffle-pool sequence.

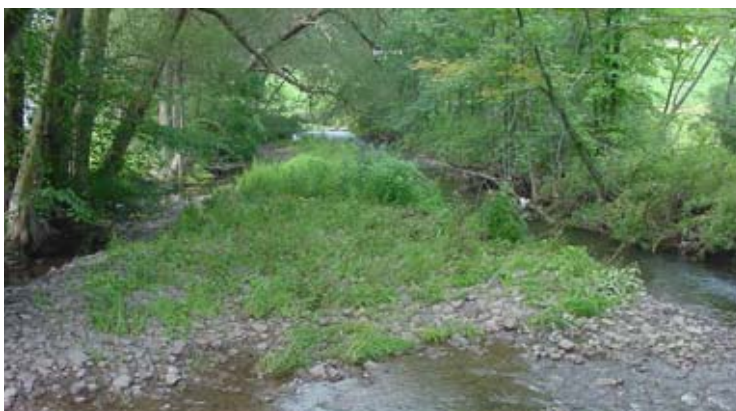
Figure 6.12 Wide and shallow flow around a gravel bar downstream of county bridge 33-1 on County Route 33, just north of Bloomville

Stream flow through many bridges during periods of low flow exhibit the characteristics of a stream that is too wide and too shallow, resulting in lack of adequate energy to effectively transport its sediment (see **Section 5.9.2** for description of width/depth relationship and sediment transport). This can result in deposition downstream of or inside the structure, which in turn

creates further flow issues (**Figure 6.12** above). Other bridges exhibit deposition upstream of the structure which is indicative of a backwater effect. Woody debris accumulations are another common concern at bridge crossings.

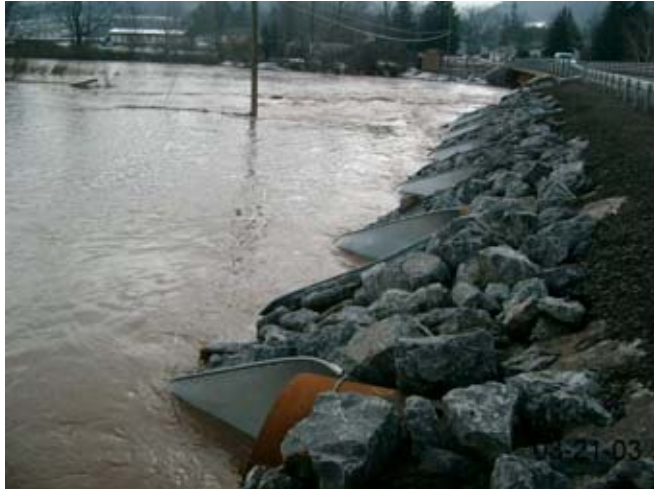
At some bridge crossings the highway approaches are elevated above the floodplain elevation. This creates an obstruction to floodplain flow, forces overbank flows under the bridge, and can create flood debris accumulation under the bridge. One solution that is being evaluated is the placement of culverts under the approaches to allow for some continuity of flood flow across the floodplain. This method has been applied where County Route 2 crosses the West Branch in Delancey (County Bridge 2-1, **Figure 6.13**). Although this application has met with some success, the practice is still being evaluated to determine its effectiveness.

Figure 6.13 Floodplain relief culverts installed at County Bridge 2-1 in Delancey. Photo taken looking upstream, March 21, 2003

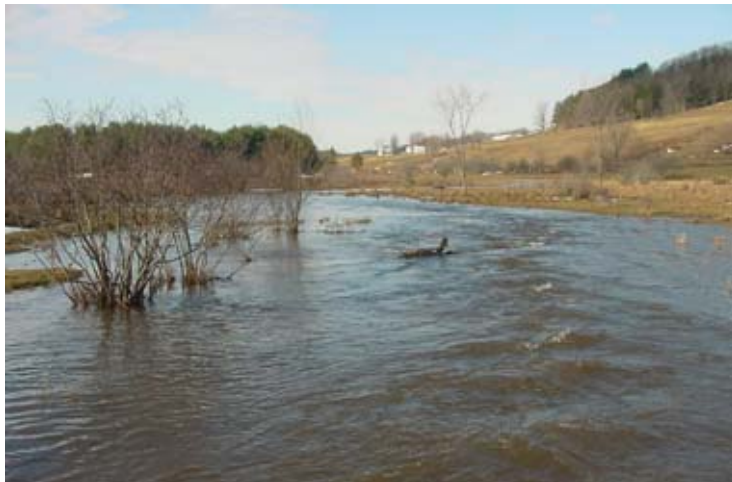
Figure 6.14 Photo of overbank flow taken just downstream of the Village of Stamford, March 21, 2003.

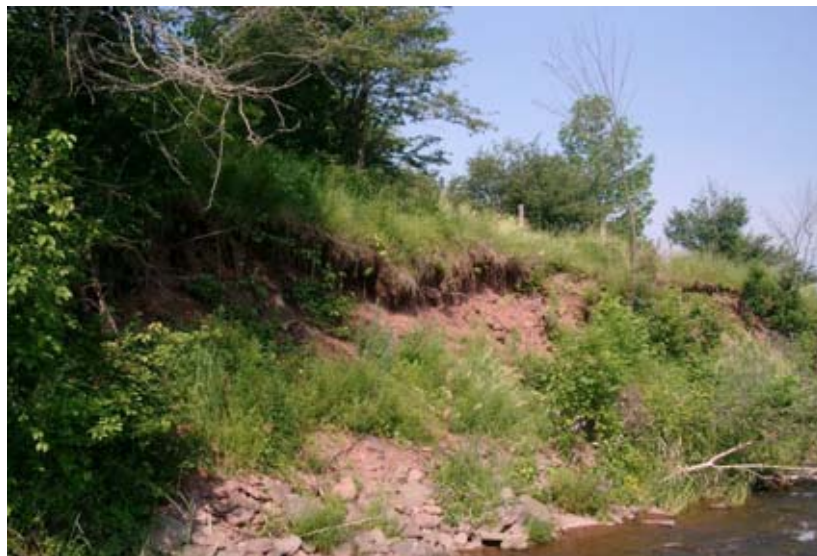
Figure 6.15 High eroding bank on Town Brook just below cross-section 10.

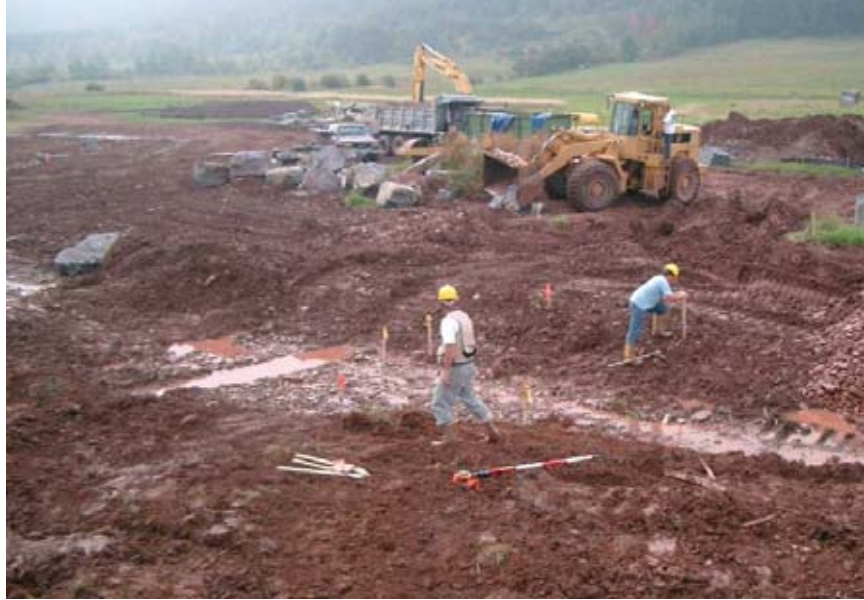
Figure 6.16 Photo taken during construction showing newly excavated channel and layout for a vane structure.
