Got "Bugs"?

A Study of the Terrace Ave. Reconstruction Site

Raymond James
Walton FFA, Walton, New York

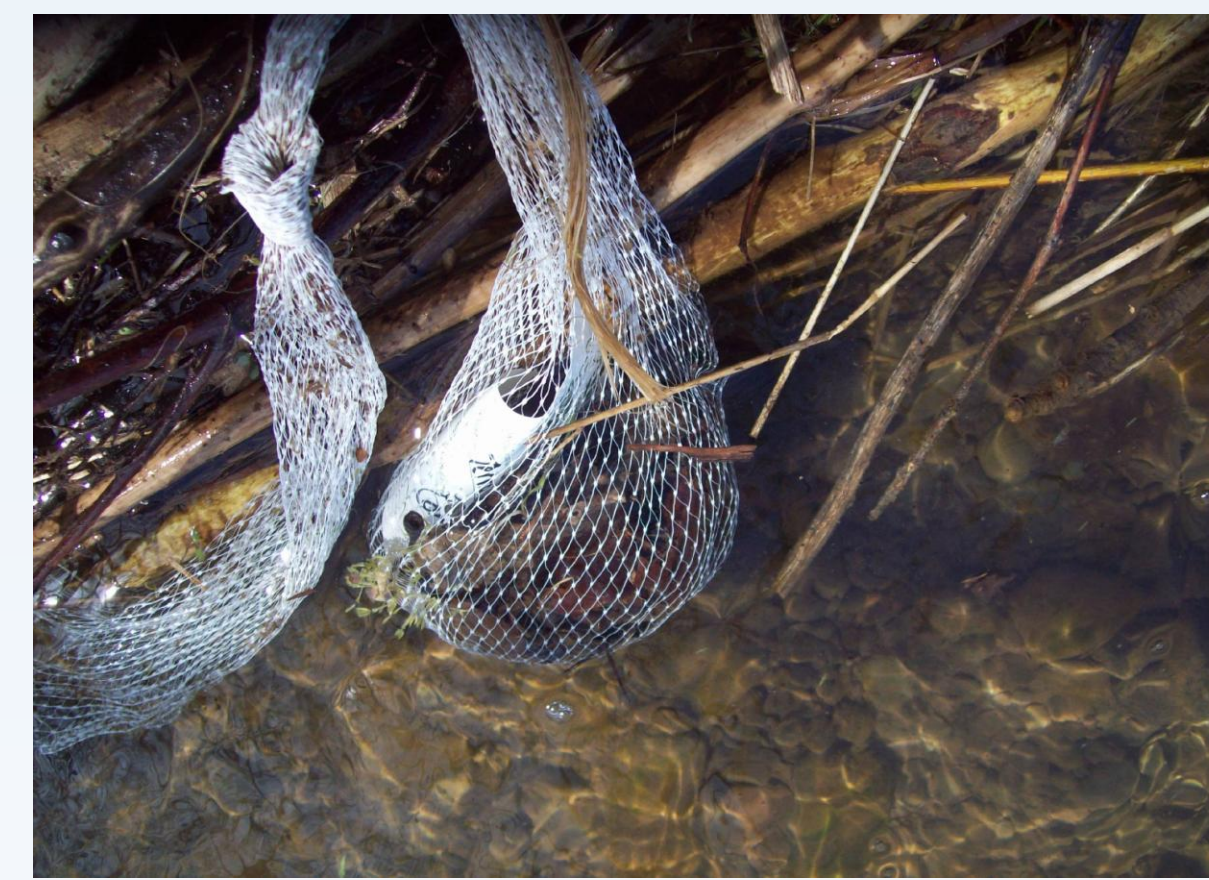
Leaf Pack Results

Three Leaf Packs were constructed using the most common leaves in the area of the study. They included Sycamore, Maple and Poplar. They were placed before, in the middle and after the reconstruction area. The packs were placed April 27, 2009 and were collected on May 26, 2009. They were then examined and all macro invertebrates were catalogued.

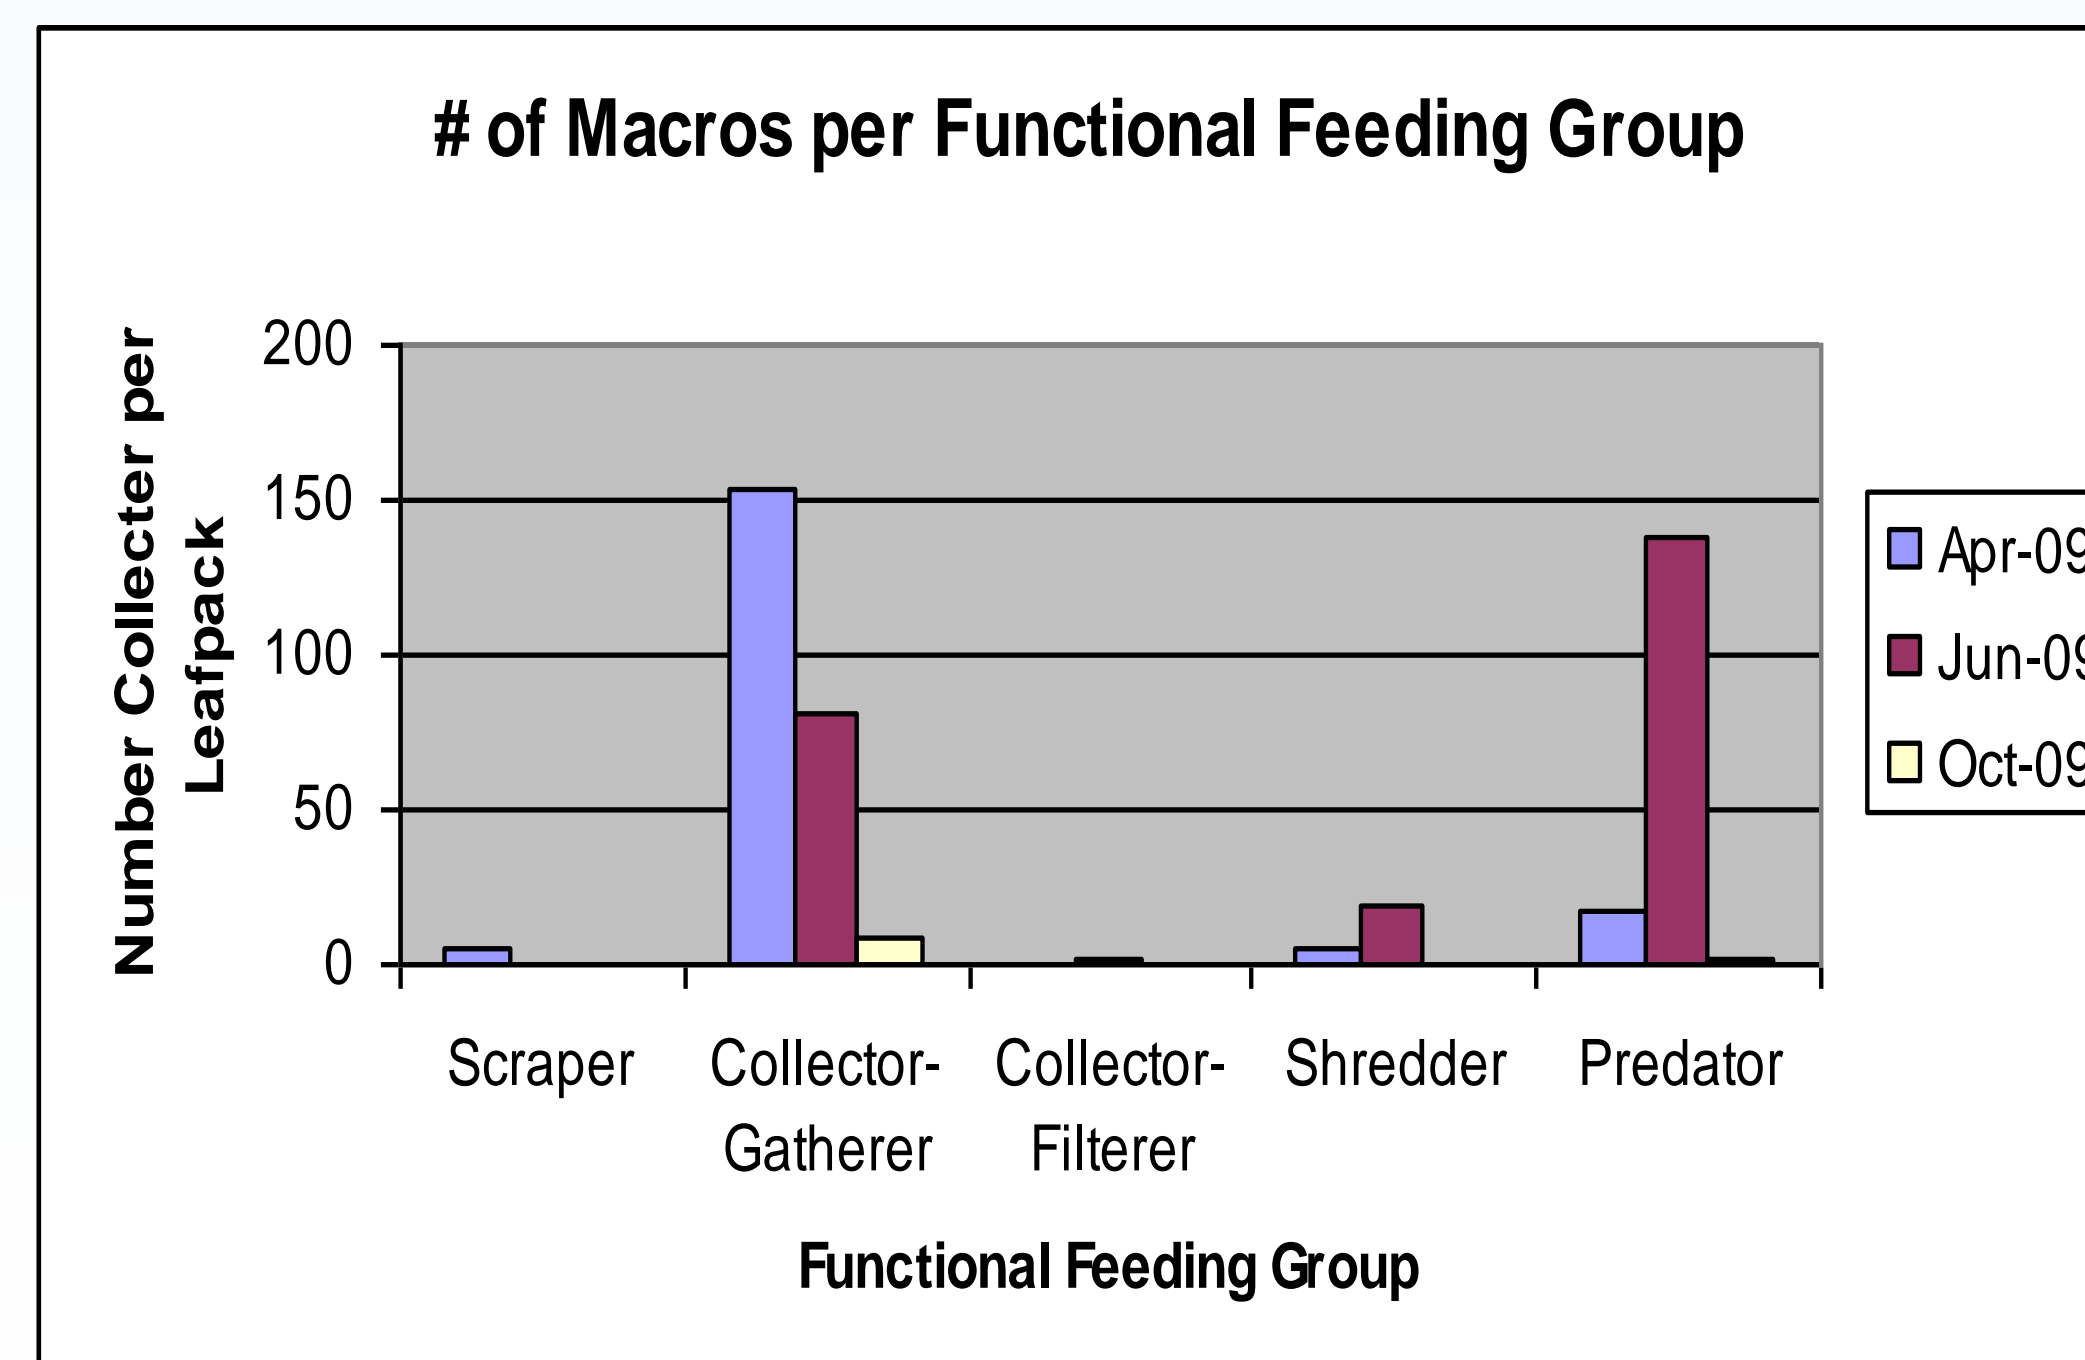
The results of this study show an EPT value of 79.0 percent. This is the total number of **E**phemeroptera (mayflies), **P**lecoptera (stoneflies), and **T**richoptera (caddisflies) that were found during the study. EPT values are important as they show the number of pollution sensitive macro invertebrates and they are the positive ones you want to find. The Biotic Index is a comparison of the abundance of taxa and their tolerance to environmental stress. The Biotic Index in the Terrace Avenue area is 3.88 on a scale of 1-10. The EPT and Biotic Index are used to monitor the sensitivity of taxa to pollution. Some insects are more tolerant of pollution than others. Although these pollution tolerant groups, which include certain true flies and worms, can be found in the cleanest streams, their numbers should not dominate the community. On the other hand, the presence of mayflies, stoneflies, and caddisflies – sometimes referred to as the “canaries of the stream” because they are so sensitive to pollution – indicates good water quality.
